SELECT STRUCTURAL

May 24, 2023

RE: Brick Wall Repairs
324 N. Main St.
Davenport, IA

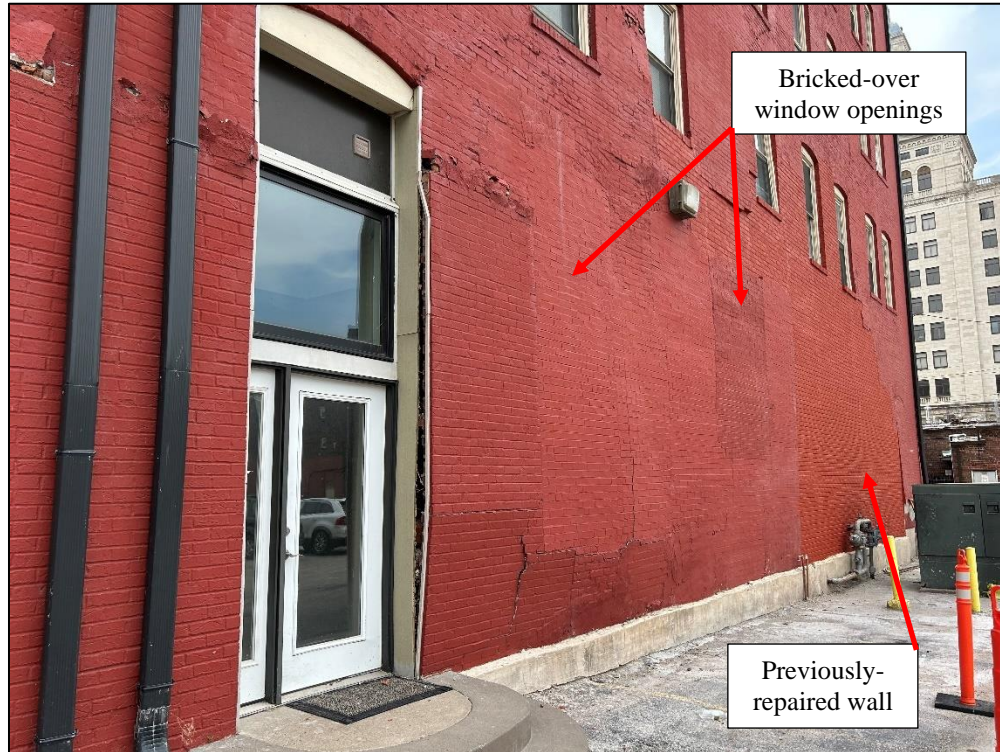
A follow-up site visit was performed at the property above on May 23rd. On the west face of the building, there are several large patches of clay brick façade which are separating from the substrate. These large patches appear ready to fall imminently, which may create a safety hazard to cars or passersby. The owner has already blocked off the area with cones and has begun removing drywall from the inside of the wall to get a view of what might be happening.

Photo 1 – Clay Brick Façade pulling away from Substrate

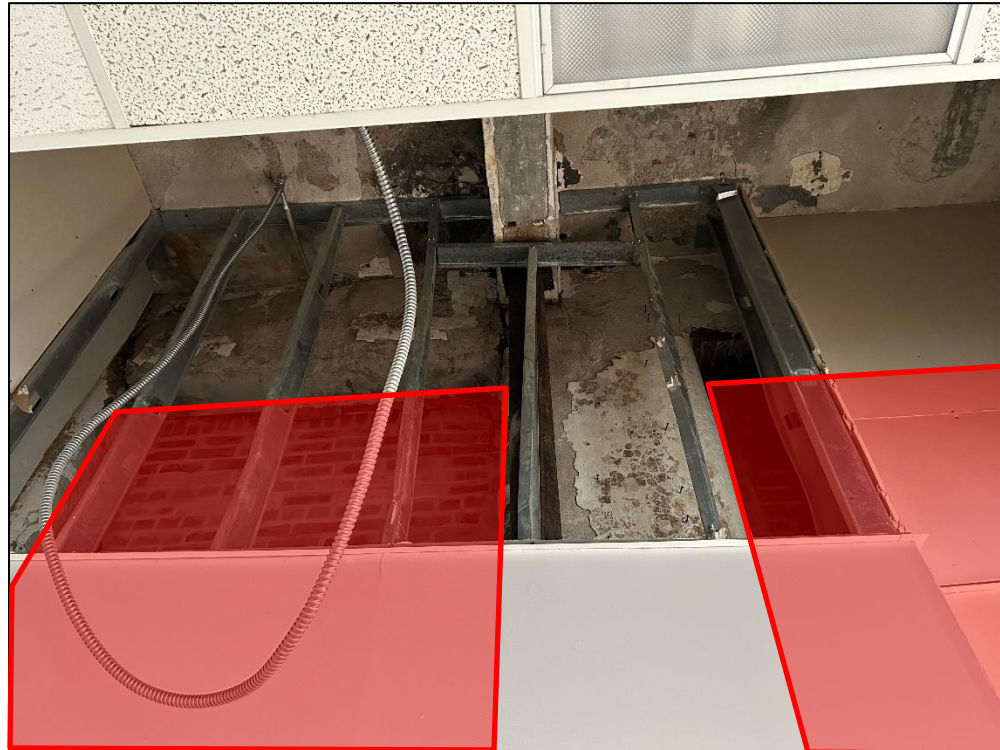
As viewed from the west exterior, there are two former window openings, roughly 12 feet tall by six feet wide, which appear to have been bricked over some years ago. The clay brick façade on and between these openings is bulging outward by several inches and looks poised to fall. In anticipation of these areas falling, the brick façade above the windows should be secured. This is to keep the entire face of the building from falling away when the bottom area(s) come loose. The same temporary façade support as was recommended on February 9th, 2023, may be used here too. Note that the elevation of the steel angle in the detail shall be at or above the top of the window openings.

Inside the first floor, the drywall is being stripped away. This reveals that the window openings were never filled with brick or block. Rather, the clay brick façade was just run right over the openings, unsupported. This lack of bracing helps explain why the façade is currently about to topple outward. The brick façade is unlikely to be preserved in place, but it can be brought down in a safe, controlled manner. The stable sections above will be secured as mentioned previously. With the loose façade removed, the window openings can be filled in with 12" wide, reinforced concrete masonry units (CMU). #5 dowels shall be drilled and epoxied into the sill of each window opening to secure the base of the infill. Four vertical #5 bars in grouted cells shall reinforce the infill wall. The top shall be capped with either solid block or a grouted bond beam such that the wall above the CMU can bear on the infill like a solid wall. After the window openings are infilled with reinforced CMU, the clay brick façade to the outside may be replaced. This time, the new façade shall be braced back against the face of the structural wall with brick pintels to keep it plumb and secure. A continuous, rigid insulation can also be installed between the CMU and clay brick façade, leaving a small air gap.

Photo 2 – Window Openings to Infill

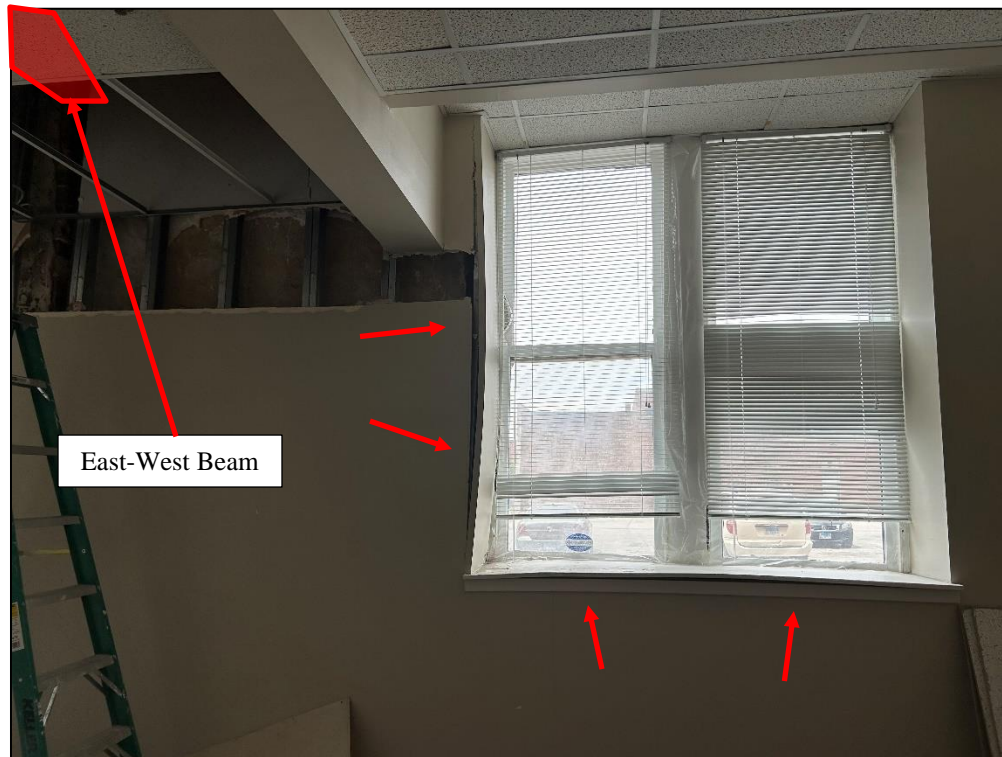
To the north of the two window openings in question, there is another issue. The wall appears to be losing some stability and is causing deformation. This is evidenced by the bowing of the interior light gauge steel furring and drywall; they bulge as if a large downward force is acting upon them. This downward force may be due to the reaction of an east-west beam which bears on the west exterior wall. Adding a steel column to support the east-west beam would alleviate much of the load from the exterior wall while the façade is rebuilt. This column may be a W6x15 positioned as near the inside face of the structural wall as possible. The cold form and drywall may be re-shaped around it to incorporate it into the re-finished wall. The brick façade outside this area may be secured and rebuilt as described for the other area.

Photo 3 – Excessive Downward Pressure on Finishes

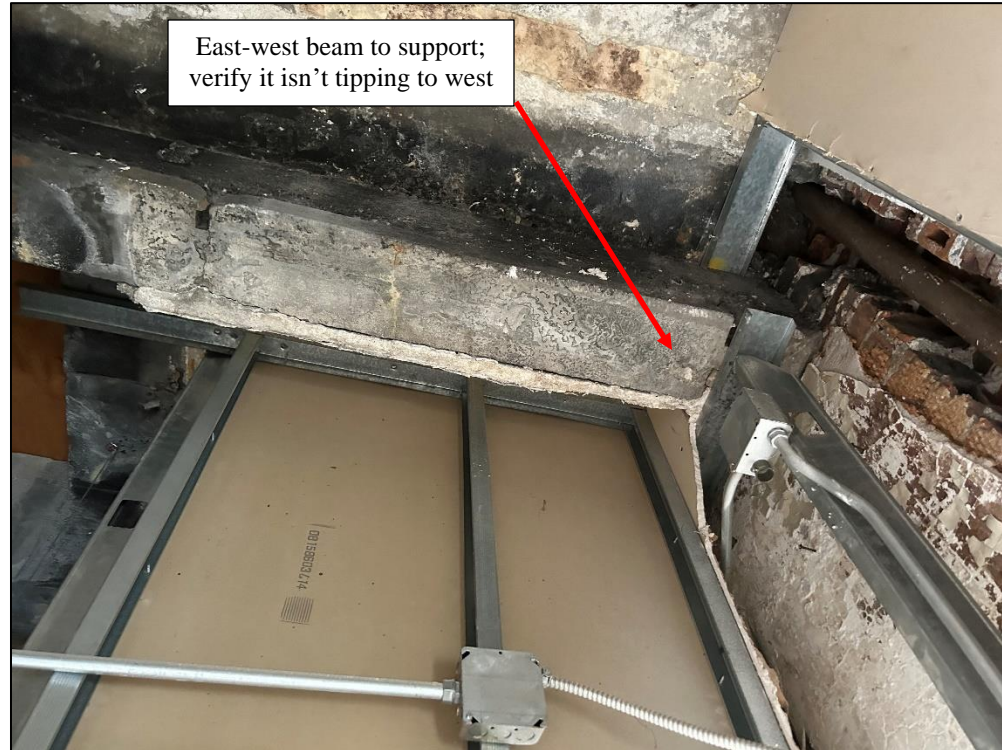
Photo 4 – Existing Beam to Support

The steel column must rest on a footing. This may be either the wall footing for the exterior wall, if it is wide enough to fit the column, or a new pilaster. The pilaster, if needed, would be a 12"x12" concrete addition to the exterior foundation wall in the lower level. This would allow the existing foundation to

support the load from the east-west beam above, which is what it should already be doing. Before fitting the steel column into position, the east-west beam should be checked to make sure it is level and has not dropped. If it remains level, then the column shall be fit to its exact height. If the beam has dropped slightly, then it should be jacked back upward to its proper level position and the column fit to that elevation. This will require field measurement and possible field cutting and/or shimming.
