SELECT STRUCTURAL

February 8, 2023

RE: Brick Wall Repair
324 N. Main St.
Davenport, IA

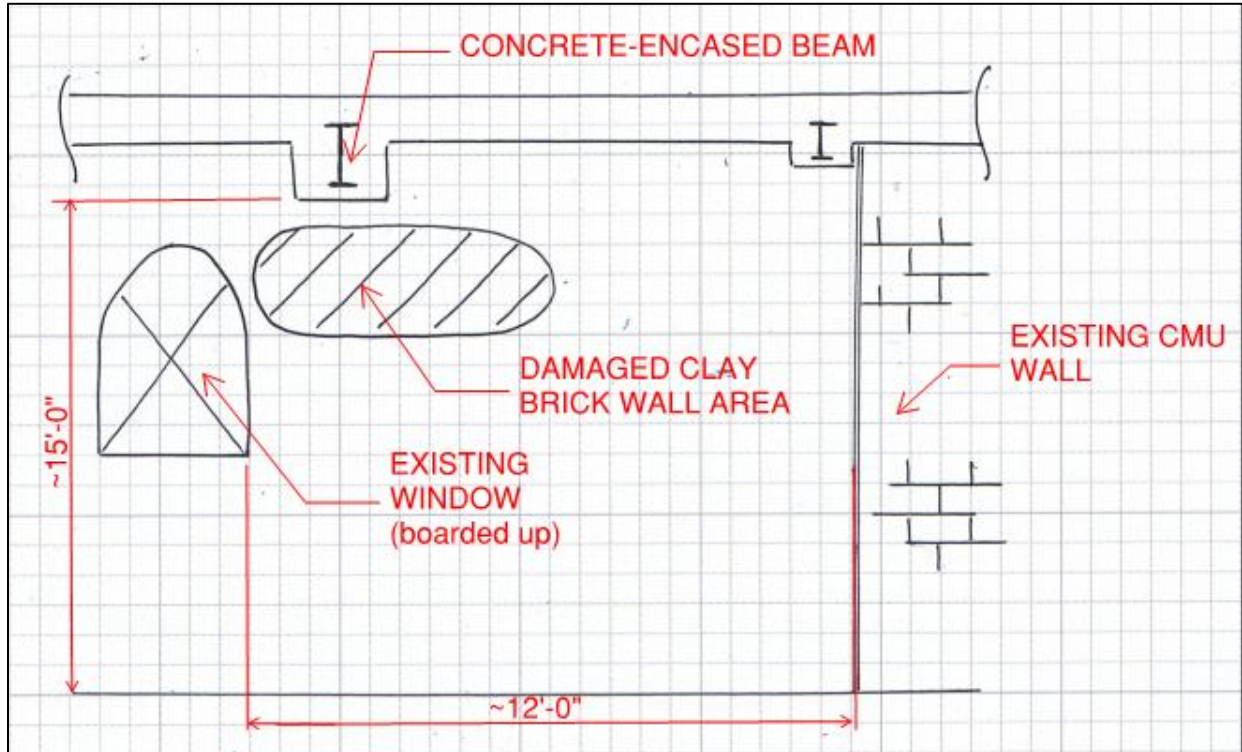
Figure 1 – Current Wall Condition

An emergency site visit was performed at the property above on February 2nd. The building is a six-story, brick and steel structure. There is commercial space at street level and residential units above. There is a concern on the west exterior wall where a localized area of brick is cracked and crumbling. This engineer determined that this is not an imminent threat to the building or its residents, but structural repairs will be necessary.

As described in the previous letter (2/2/2023), there are two east-west beams in the vicinity of the west wall which need to be shored. With these secured, reconstruction of the wall can commence. The clay brick wall appears to be three or four wythes thick. The damaged area is roughly eight feet long by four feet high, mainly under the larger east-west beam. The full height of the wall in this area should be replaced. A suitable replacement would be a concrete masonry unit (CMU) wall.

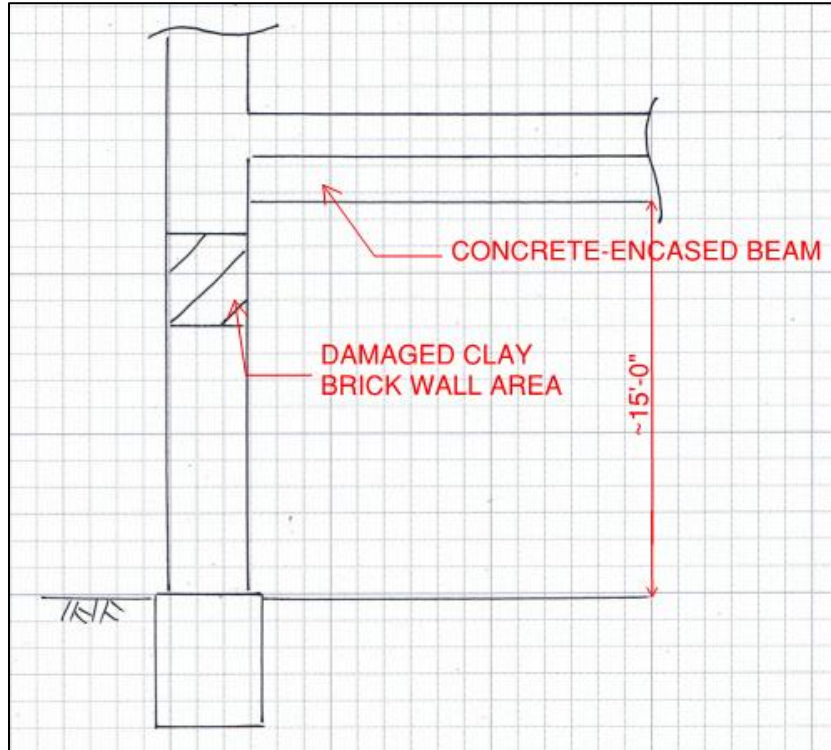
Figure 2 – Current Wall Condition (Section View)

It is unknown if there is a north-south steel beam inside the wall at the second floor level, or if there is a steel post encased in the brick which supports the encased east-west beam. It will therefore be conservatively assumed that the east-west beams bear directly on the brick wall to be replaced. This is further reason to replace the wall in smaller segments to minimize the area and duration of unsupported walls above. If, however, steel members are encountered during demolition, they are to be preserved and undamaged. Notify the Engineer of their presence. These members are not to be removed or damaged so that they can be reused and incorporated into the repairs. The new CMU wall will be built around any such members, encasing them as before.
